# Manhole Inspection Summary

Manhole # S35II1006MH

Insp Date: **1/22/07 2:41 PM**

**Location** Address: **216 WENDOVER RD**

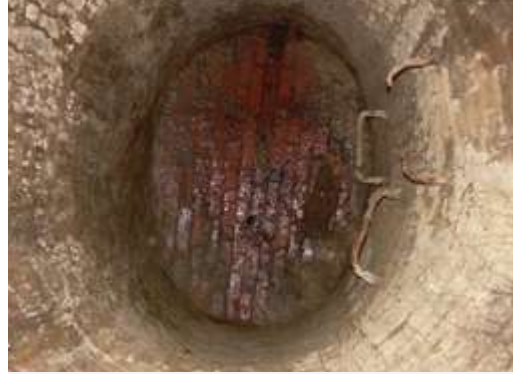
Top View

Corroded and missing steps. Channel debris.

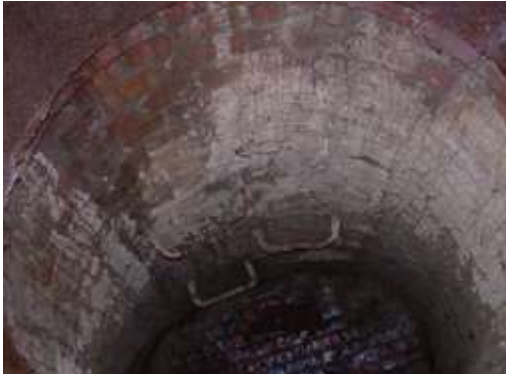
Defect

☒ **Leaks**

Condition: ☐ Sound ☐ Cracked ☐ Root Intrusion ☐ Loose Brick ☒ **Deteriorated**

Infiltration: ☐ None ☒ **Joint** ☐ Cracks ☒ **Mortar** ☐ Roots ☐ Wall

Infiltration: ☐ None ☐ Joint ☐ Cracks ☐ Mortar ☐ Roots ☒ **Wall**

Frame leaks. Adjustment deterioration and infiltration. Corbel and Barrel infiltration.

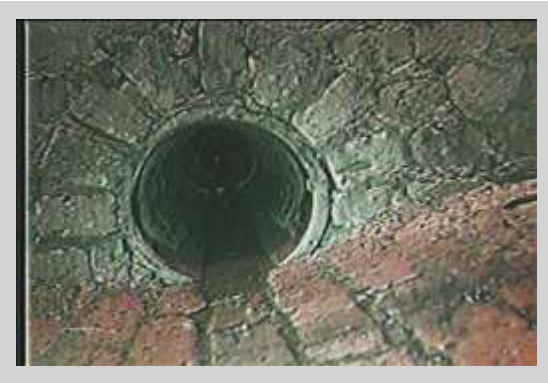
8 in. Circular Gravity Sewer  
Pipe Out @ 12 O'Clock

Condition: ☐ Sound ☐ Cracked ☐ Root Intrusion ☐ Loose Brick ☒ **Deteriorated**

Infiltration: ☐ None ☐ Joint ☐ Cracks ☒ **Mortar** ☐ Roots ☒ **Wall**

Barrel deterioration and infiltration.

Deposits: ☐ None ☒ **Mud** ☐ Sludge ☒ **Debris** ☒ **Grease**

Infiltration: **None** Pipe Seal Cond: **Cracked**
